Service Bulletin

Horizontal Stabiliser Trim Indicator Inspection

GA8 serial numbers GA8-00-004 through GA8-06-100.

Document: Service Bulletin SB-GA8-2006-35

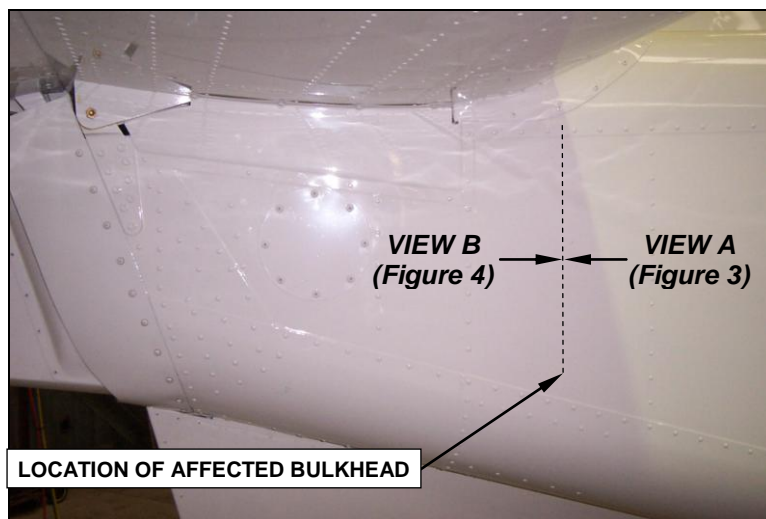
Figure 2

Situations have arisen where the trim position indicator reaches the end of its travel before the horizontal stabiliser is adjusted to the full leading edge down (i.e. nose up trim) position. When this occurs, further movement of the trim wheel may possibly lead to damage of the trim cable clamp mount, attaching bulkhead and associated hardware.

- 1.4. If deflection of the trim indicator cable mount occurs with the horizontal stabiliser trimmed to the full leading edge down position, an inspection for cracking and other damage of the bulkhead and cable mount is required. To adequately inspect the bulkhead (location indicated in figure 2), remove the large access panel on the lower tail cone skin and inspect the forward face of the bulkhead around the trim indicator cable mount attaching fasteners (refer to figure 3). If defects are found, contact Gippsland Aeronautics. If no defects are found, perform the adjustment to the trim indicator cable in accordance with section 2 of this Service Bulletin (Rod End Adjustment Procedure).

For all applicable aircraft, inspect the horizontal stabiliser trim indicator clamp mount and the attaching bulkhead (refer to figure 2) in accordance with the inspection procedure detailed in section 1 of the instructions contained in this Service Bulletin at the next 100 hour/annual inspection after 30 April 2006.
