Service Bulletin

Elevator Hinge Upgrade

GA8 serial numbers GA8-04-054 through GA8-07-114, and any GA8 aircraft prior to S/N GA8-04-054 retrofitted with machined hinge brackets by Engineering Release.

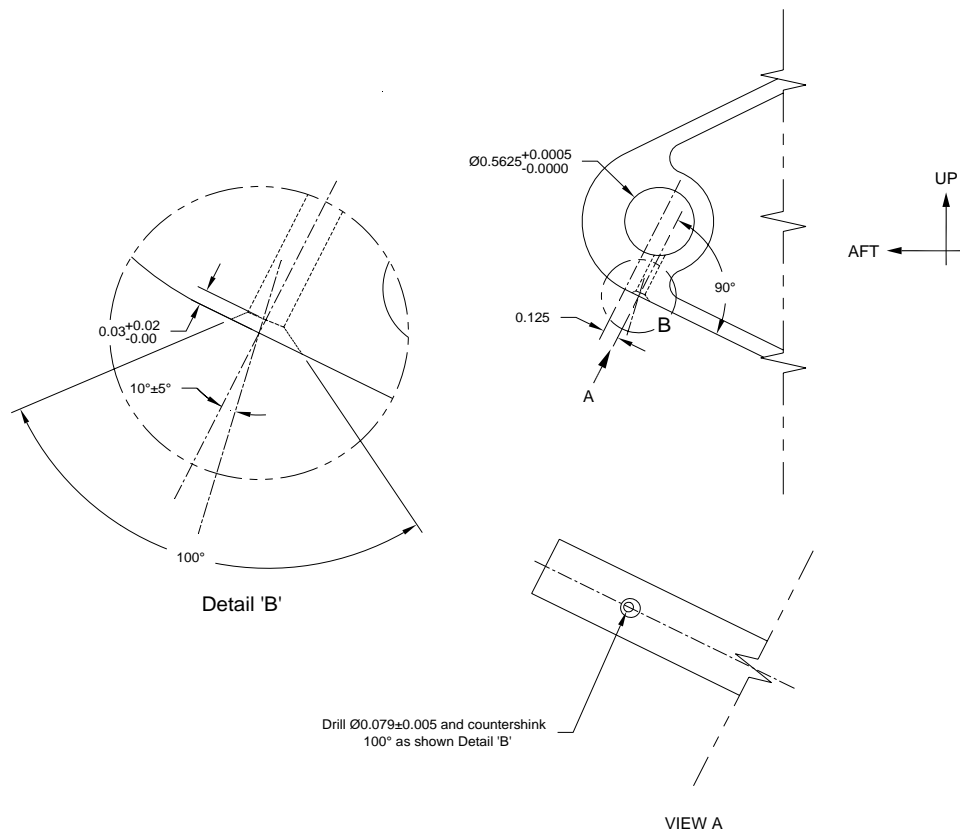
Figure 1

Issue 3: Lubrication hole moved 0.125". See Figure 1.

- 1.3. Drill lubrication holes of diameter 0.079" ± 0.005" [2.00 mm ± 0.13 mm] in the elevator hinge brackets in accordance with figure 1, and countersink at 100° as shown.
