Service Bulletin

Overheating of overhead electrical connection used by cabin fresh air blower.

All GA8 aircraft with serial numbers GA8-00-004 to GA8-06-104, GA8-06-106, GA8-06-107, GA8-07-109 and GA8-07-111.

Document: Service Bulletin SB-GA8-2009-56

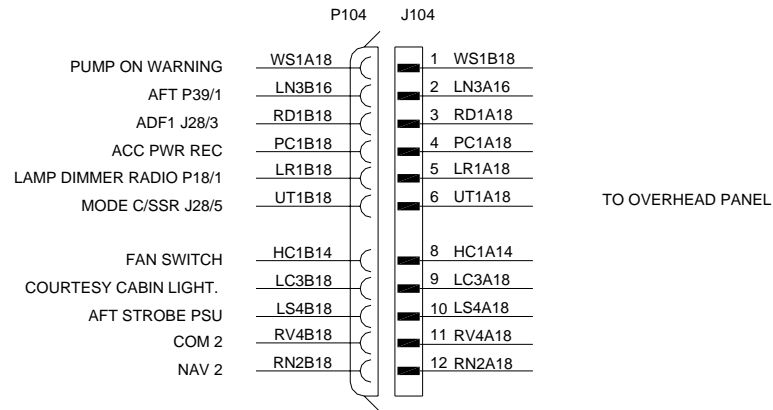
- 1.1. Pull or open all the underfloor circuit breakers.
- 1.2. The affected connectors P104 and J104 are located port side just aft end of the electrical overhead panel. Refer to Figure 1. Remove the forward most centre interior roof panel to access the connectors. Pin 8 of the connectors are used for the blower fan circuits, HC1A14 and HC1B14.

- 2.1. Replace the electrical plug and cap housing and associated crimp contacts as per original aircraft wiring. Connector P104 requires housing part number 1-480708-0. Connector J104 requires housing part number 1-480709-0. Refer to Figure 1 of this Service Bulletin for the pinout for each connector. The 18AWG wires require crimp contacts 350689-1 & 350690-1. The 14 and 16 AWG wires require crimp contacts 350547-1 and 350550-1. Crimp tool HTR 11-01-0084 (Sargent Tools) is recommended for this task. Use nest A for 18 AWG wire and nest B for the 14 and 16 AWG wires.

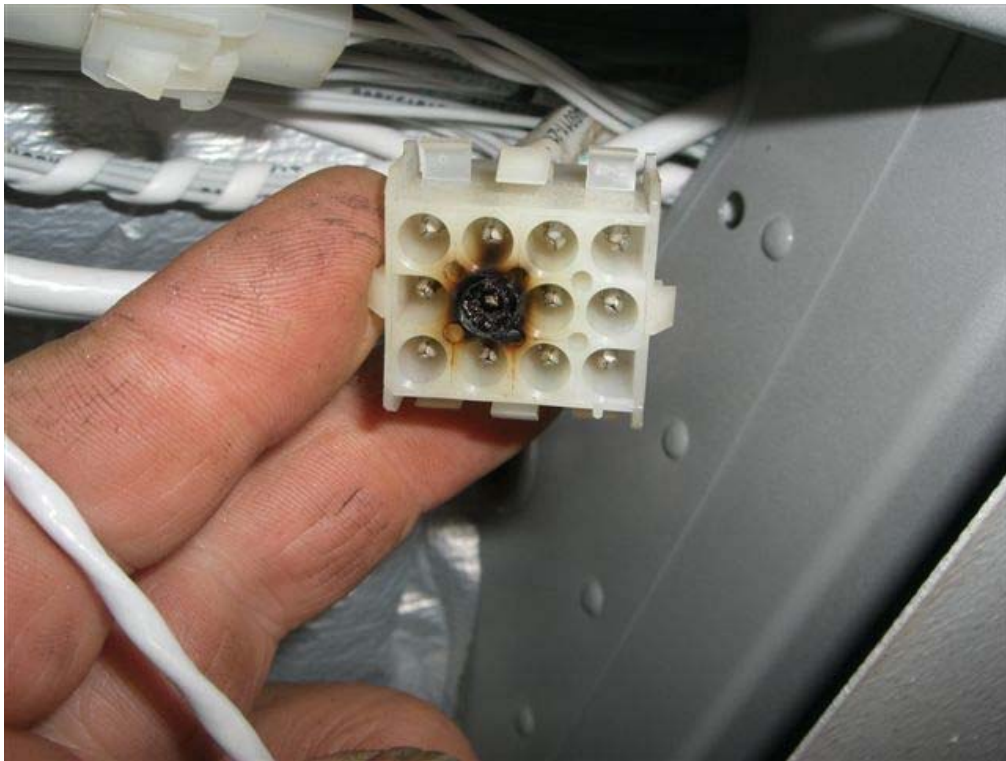
Figure 2

There have been some field reports indicating overheating of the connector plug J104/P104at pin 8 between the aircraft wiring loom and the overhead electrical panel.

- 1.3. Inspect the connector for signs of burning or charring. Figures 2 and 3 depict damaged connectors.

- 2.2. If possible, remove the contact crimp pin and socket attached to circuits HC1A14 and HC1B14 from connectors J104 and P104. Cut off the crimp contacts. If the crimp contacts associated with circuits HC1A14 and HC1B14 can not be readily removed, cut the wires as close as possible to the rear of each of the connectors.
- 2.3. Cut a length of 14 AWG wire (M22759/16-6-9) to 12". Using male and female lug terminals insert the 12" length of wire in between circuits HC1A14 and HC1B14 as shown in Figure 4. The connections are to be covered in heat shrink tubing. Refer to the Parts table for terminal part numbers.
