Service Bulletin

Forward Fresh Air Ventilation System Retrofit

All GA8 serial numbers GA8-00-004 through GA8-04-054.

Document: Service Bulletin SB-GA8-2005-19

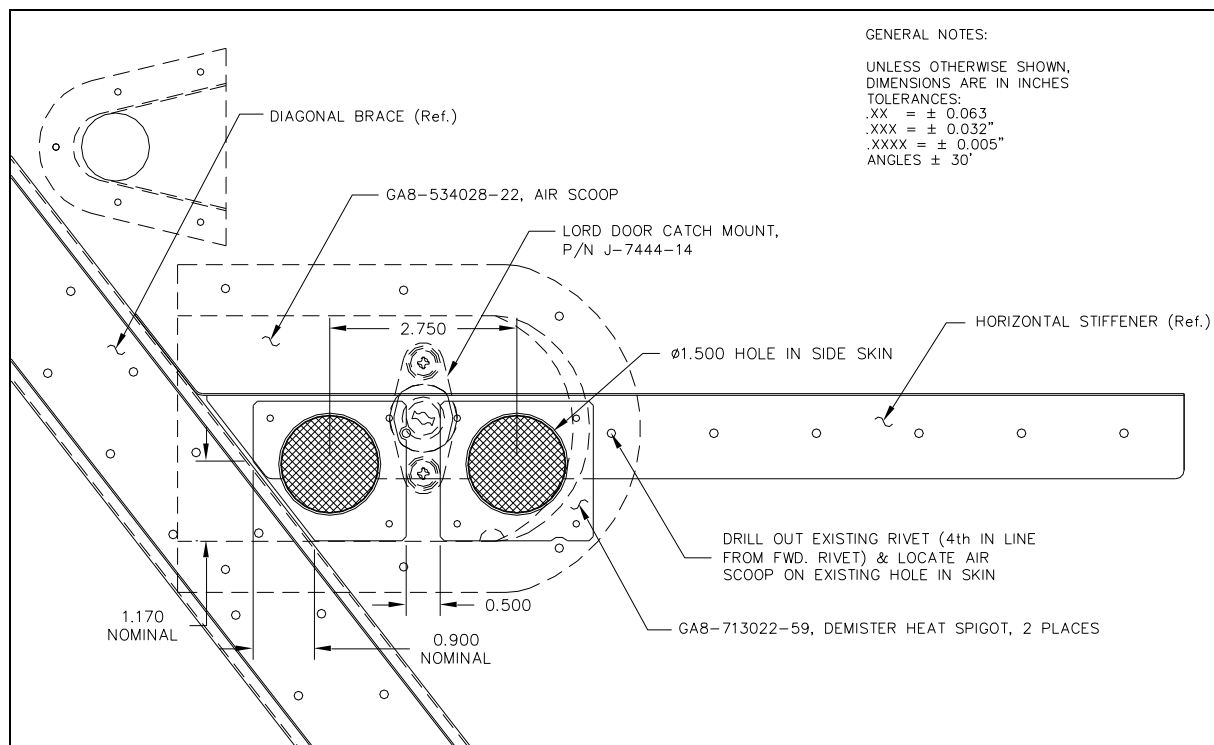
Figure 1: Installation drawing showing the right forward side skin from inside the aircraft.

3. Disconnect existing SCAT6 ducts from their respective forward side vent assemblies, P/N GA8-534017-11.
4. Two spigots are to be attached to each of the left and right forward side skin, P/N GA8-534023- as per figure 1. Trim the forward spigot such that it will abut the horizontal stiffener, P/N GA8-534023-61(R)/-39(L) and the diagonal brace, GA8-534023-35 (from S/N GA8-00-004 up to and including S/N GA8-04-048) or P/N GA8-534023-83 (S/N GA8-04-049 and subsequent). Refer to figure 1 for key dimensions regarding spigot installation.

10. Locate the air scoop to the drilled out hole to the middle hole at the aft end of the air scoop.
11. Ensuring that the air scoop is level, drill 1/8" (#30 or 3.3mm) clearance holes through the air scoop and side skin as per figure 1. Temporarily secure the air scoop to the side skin.

15. Mark and drill 5/32" (#21 or 4.0mm) clearance holes in the side skin and install the Lord door catch mount in accordance with figures 1 and 2. Lord door catch mount may be further spaced with AN960-10 washers as required for flush finish with the air scoop.

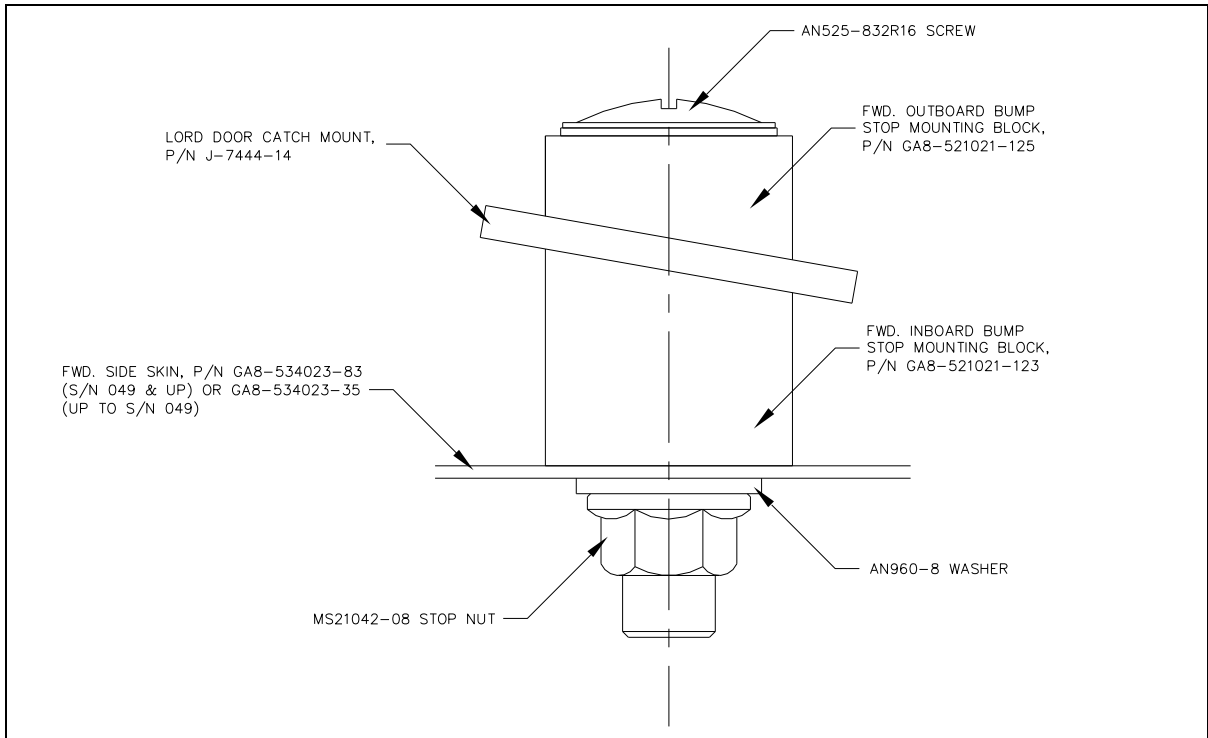
Figure 2: Installation of Lord door catch mount.

13. Cut a 1.000"±0.063" (25.400mm±1.588mm) hole in the air scoop centred on the point where the Dzus lines up.
14. Fit the Lord door catch mount into the air scoop with the "LORD" label upright and the holes in the base aligned vertically between the two spigot openings.

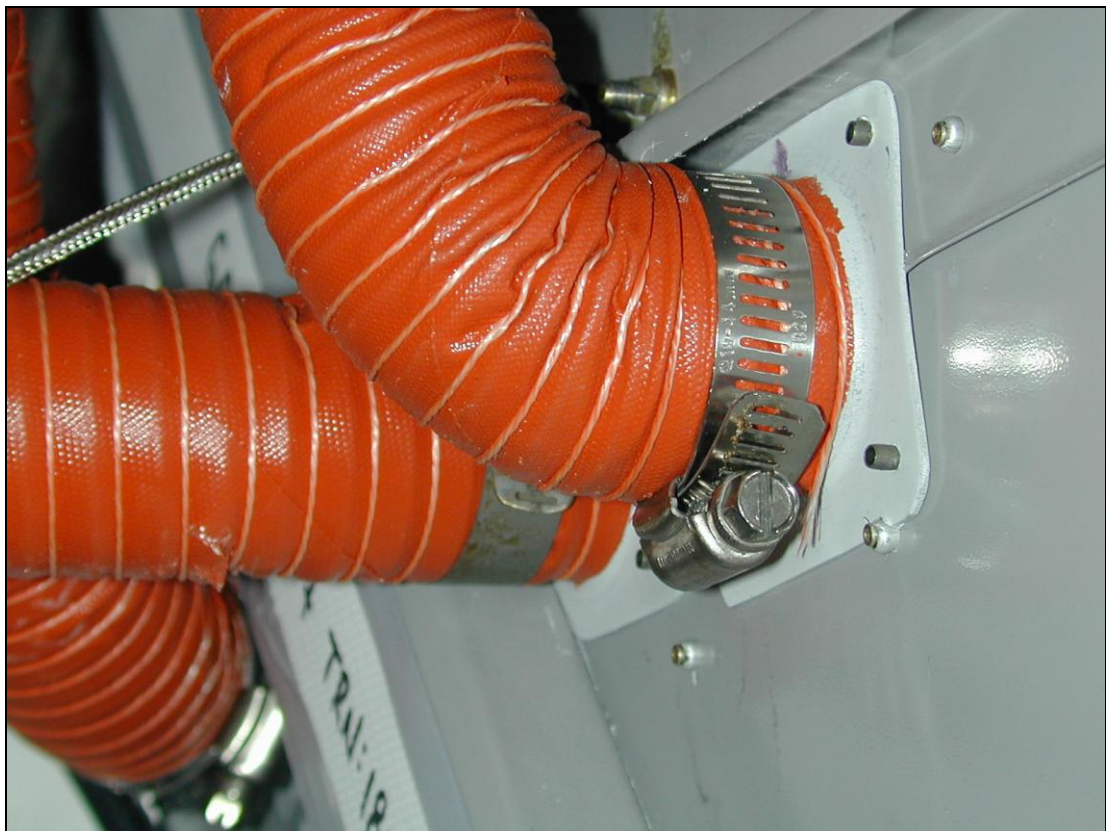
Figure 3: Completed RHS modification viewed from inside the aircraft.

20. Trim insulation panels, P/N GA8-258012-45 to fit, and reinstall insulation panels.
21. Refer to figures 3 through 6 showing various aspects of the completed installation.

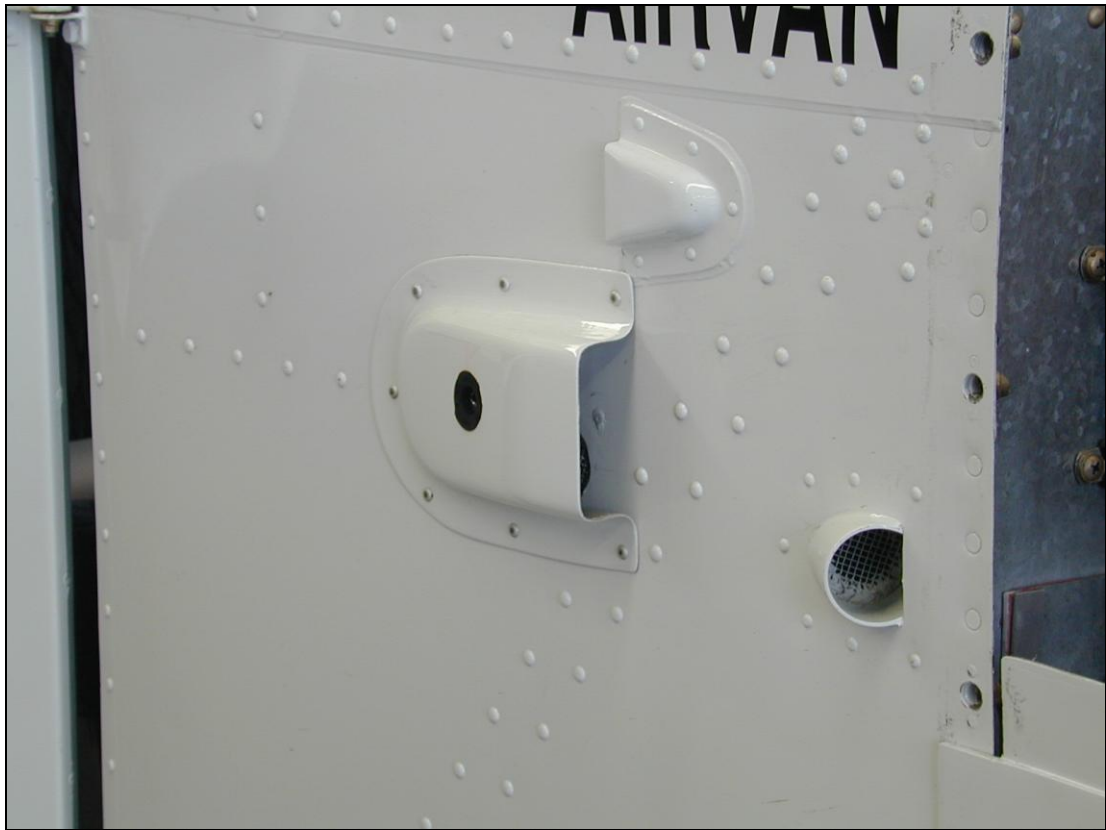
Figure 4: Completed RHS modification.

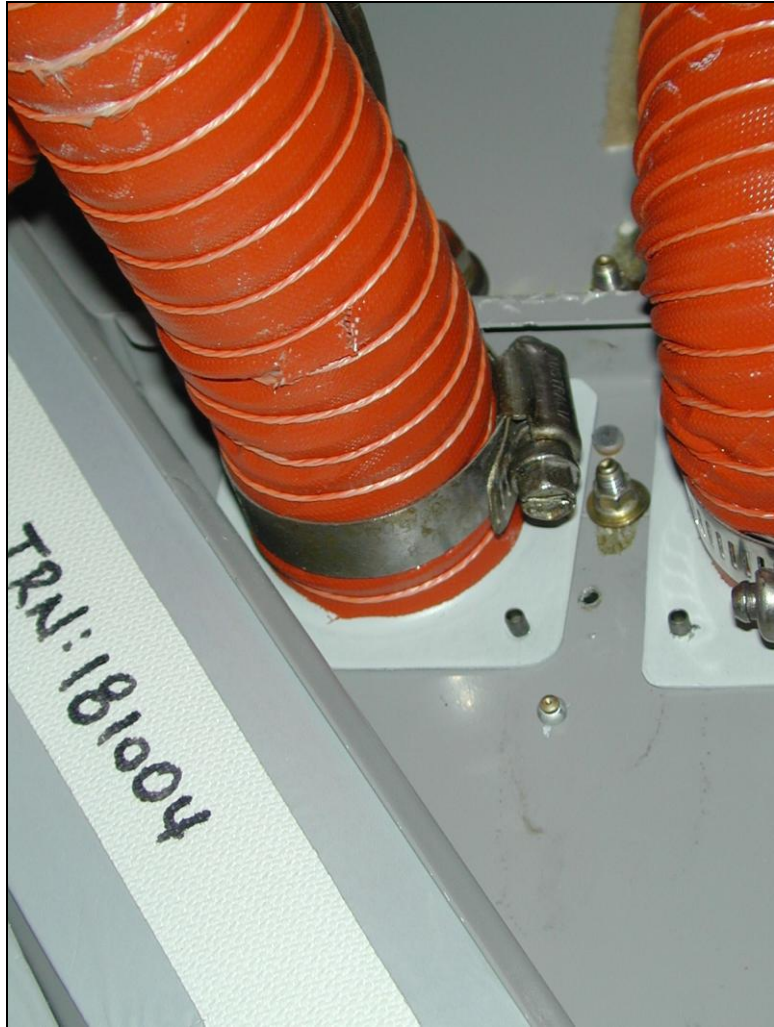
Figure 5: Completed RHS modification viewed from inside the aircraft.

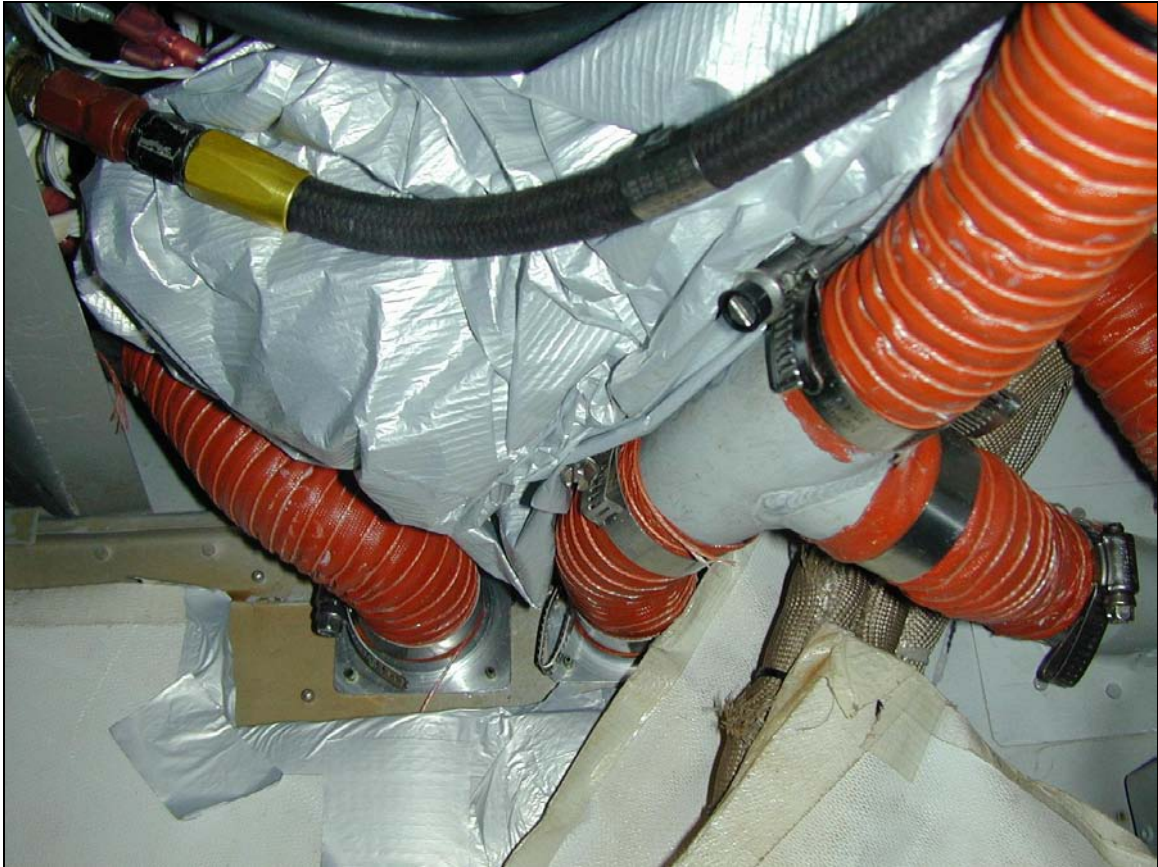
Figure 6: Completed LHS modification viewed from inside the aircraft.

19. On LHS connect SCAT6 from the original side vent and forward spigot via the original T junction to the inboard vent as per figure 6. Connect SCAT6 from the LHS aft spigot to the outboard vent.
